2023 Barren Box Project

Annual Environmental
Management Report

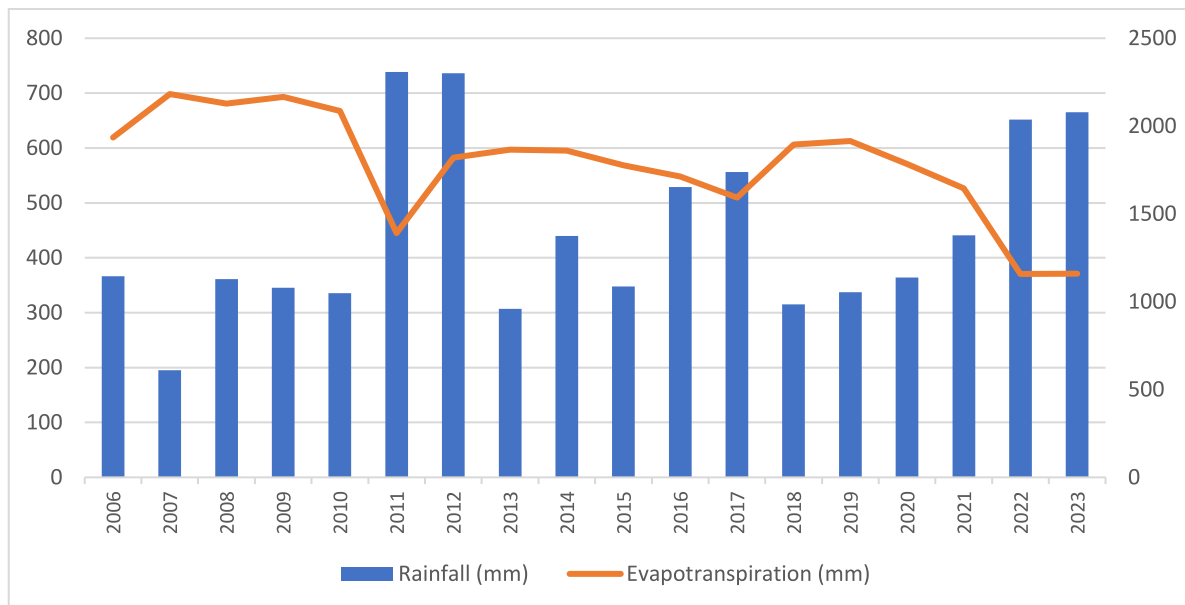
Figure 1: Rainfall and evapotranspiration for financial years 2006-2023

The weather conditions between the completion of construction of the BBS project (August 2006) and 2023 have varied significantly. This included the end of the Millennium drought and floods in 2012, 2016/17, and 2022 (**Figure 1, Appendix C**).

Rainfall has continued to increase throughout the last five years with above average rainfall recorded for 2022/23. There was a 12mm increase compared to last year 2021/22 and 223mm compared to 2020/21. The evapotranspiration remains consistent with the prior year 2021/22.

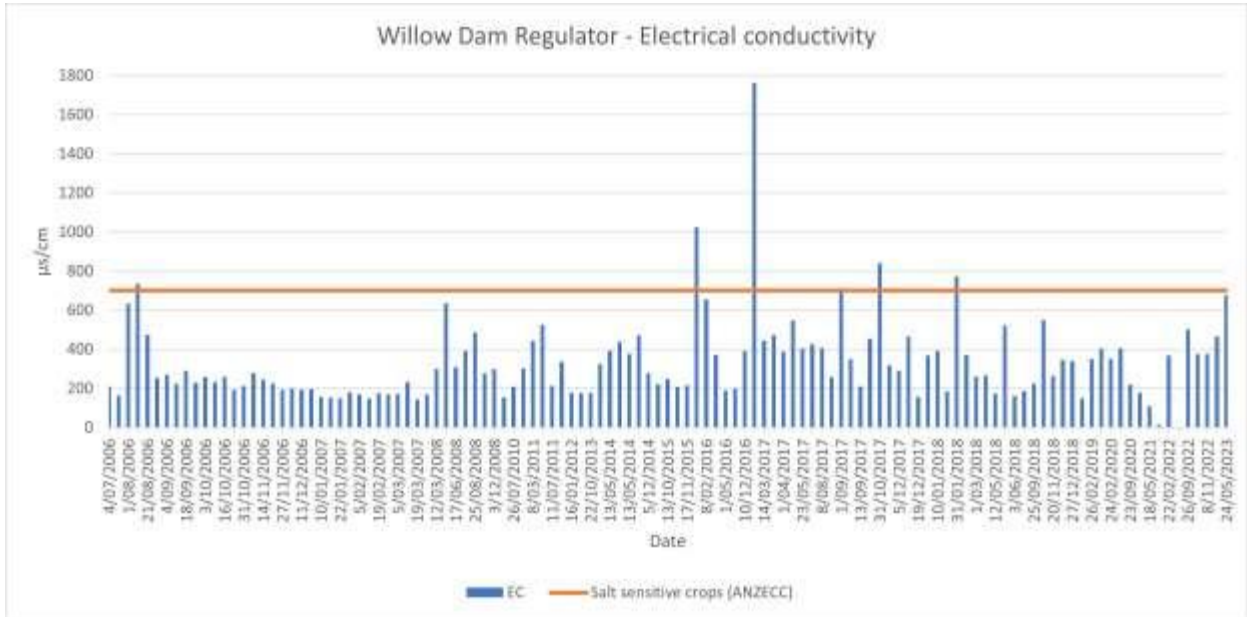
Figure 9: Electrical conductivity at Willow Dam Regulator – 2006 to 2023

The locations where water is monitored and/or sampled under MI’s Water Monitoring Plan are presented in **Figure 8**. The locations are described below, and graphs of the EC are provided from **Figure 9** to **Figure 13**.

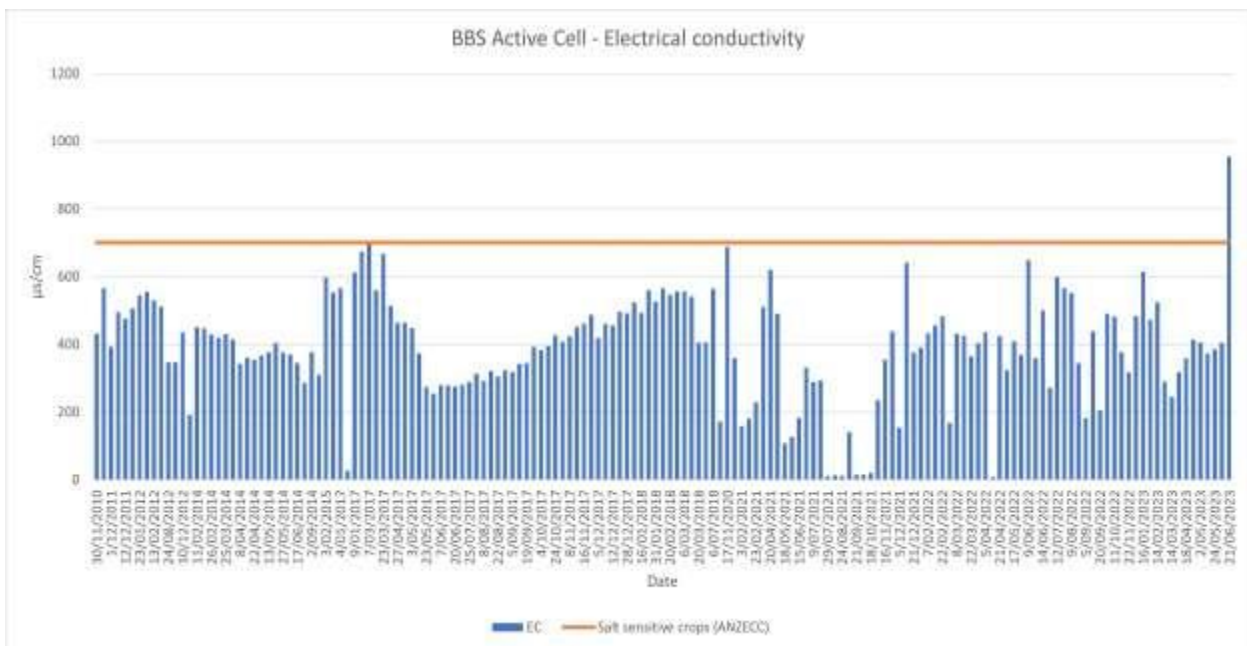
Figure 10: Electrical conductivity in BBS Active Cell – 2010 to 2023

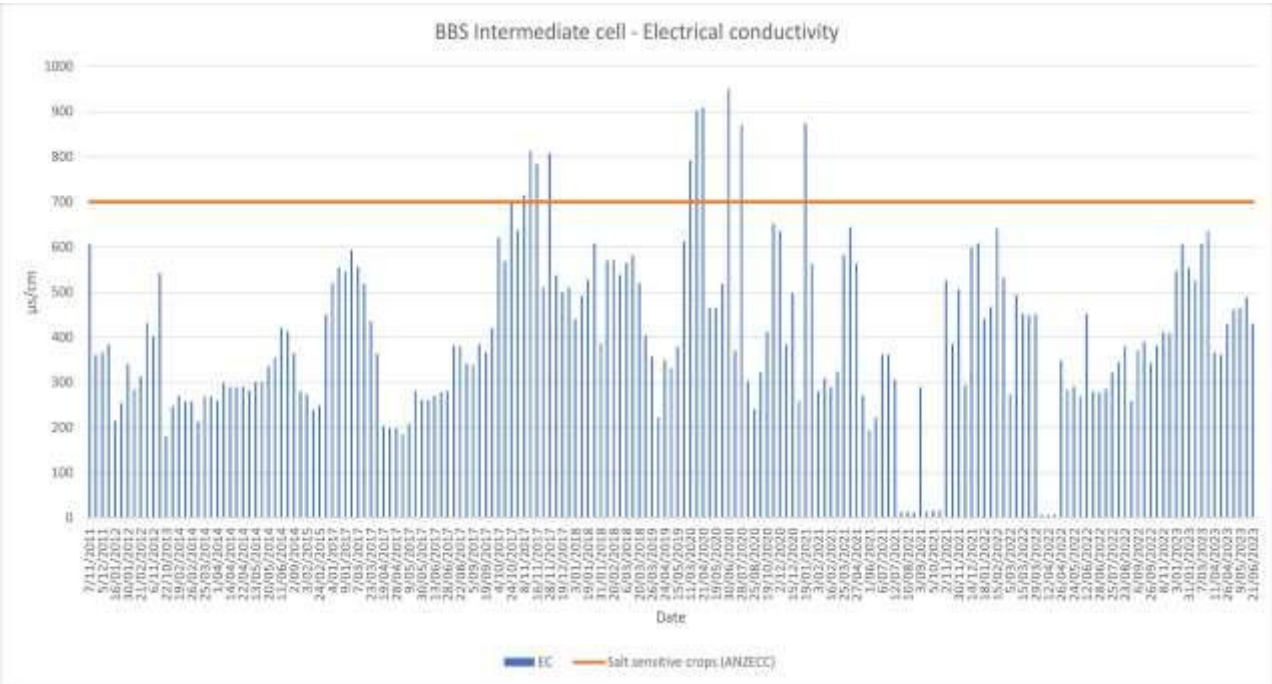
Figure 11: Electrical conductivity in BBS Intermediate Cell – 2011 to 2023

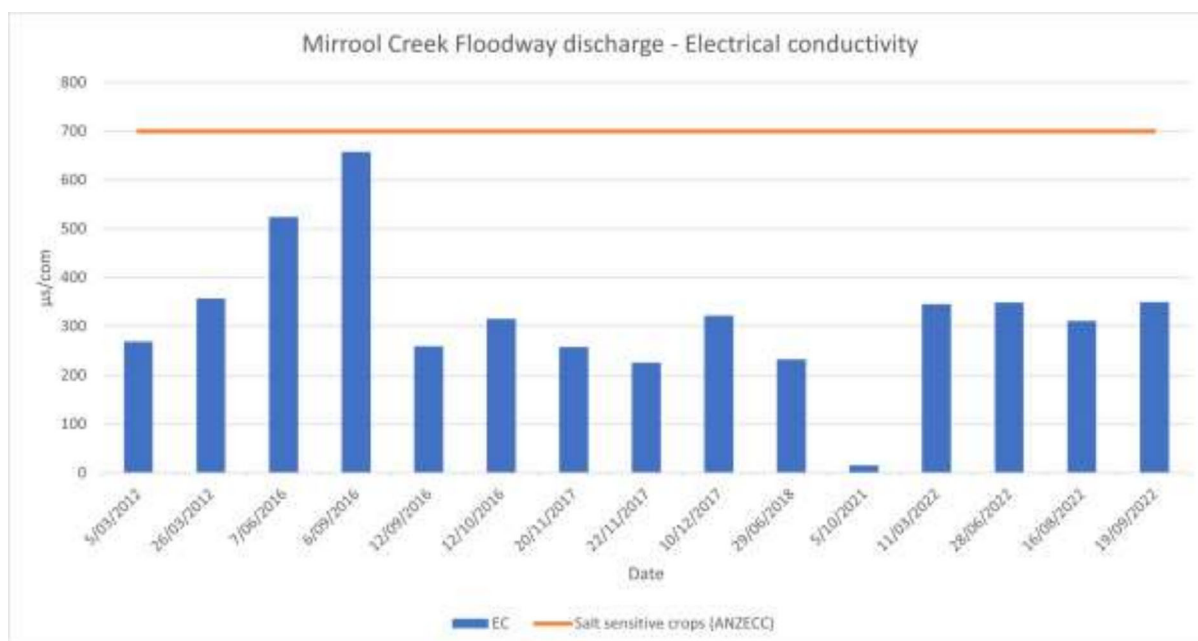
Figure 13: Electrical conductivity at Mirrool Creek Floodway for release events– 2012 to 2023

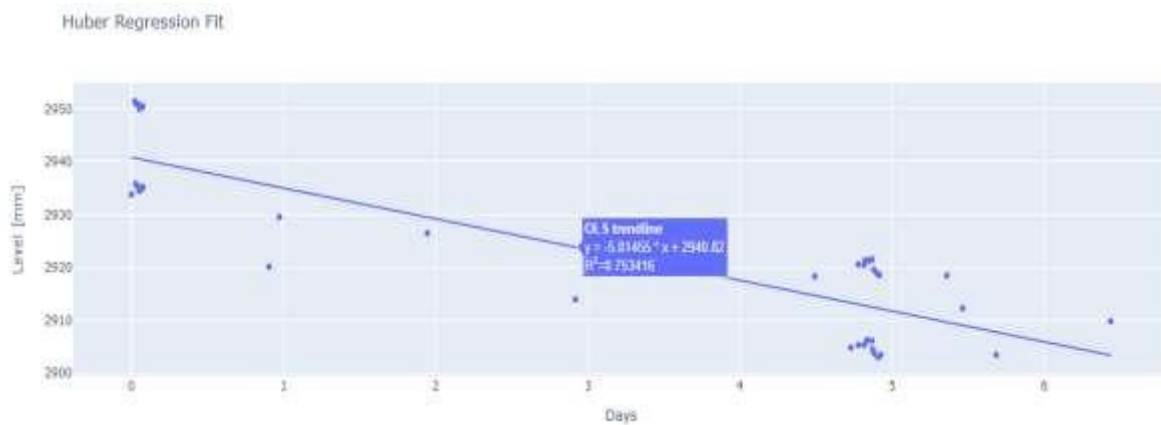
Figure 19 below shows the rate of change in level during the lock up period during July 2022, it shows a reasonably good fit to the data ($r^2=0.75$):

Figure 19: Huber regression for Brays Dam lock up data 2022

The loss calculation includes both evaporative losses and any influence on water levels due to wind action during the lock up period, so would be expected to be higher than actual seepage losses. Data from BOM show that the annual evaporation rate (Class A evaporation pan) from 1975-2005 data is 1800mm.

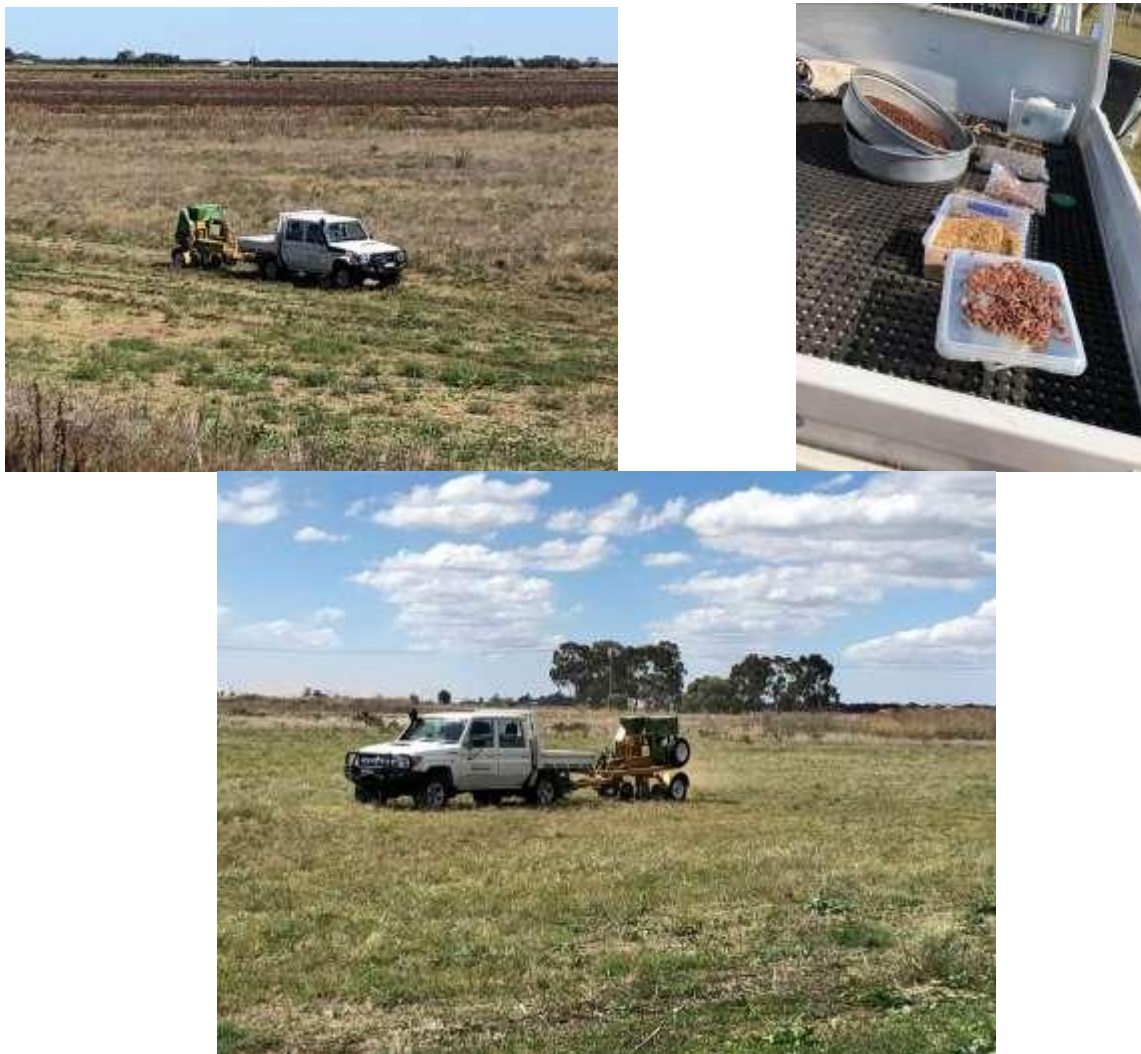
Photo 1: Direct seeding performed on 9 April 2021 by Riverina Revegetation Pty Ltd

Direct seeding was undertaken on 9 April 2021 by specialist contractor Riverina Revegetation, following delays due to rain. In March 2022, good establishment was noted from the seeded zones as shown in **Photo 1** and **Photo 2**.

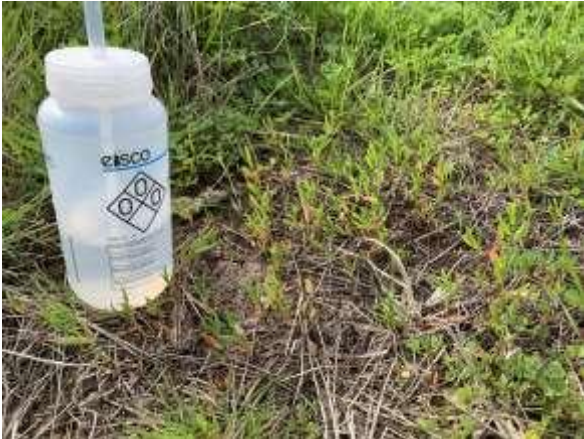
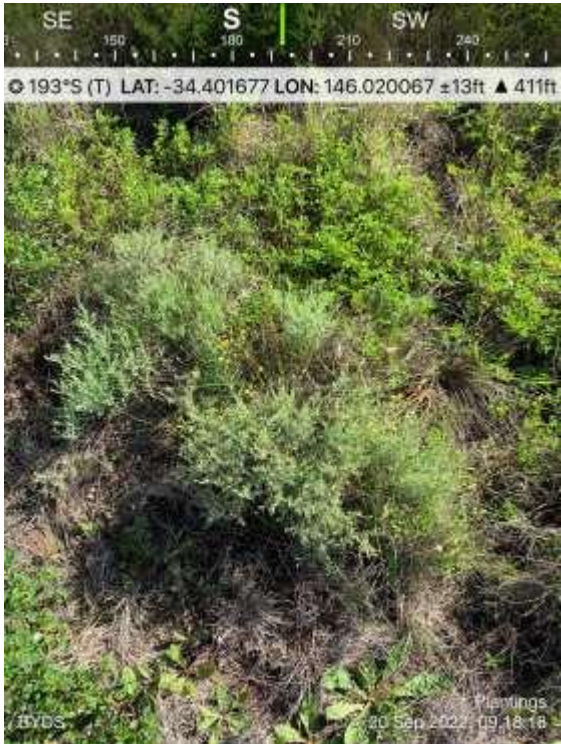
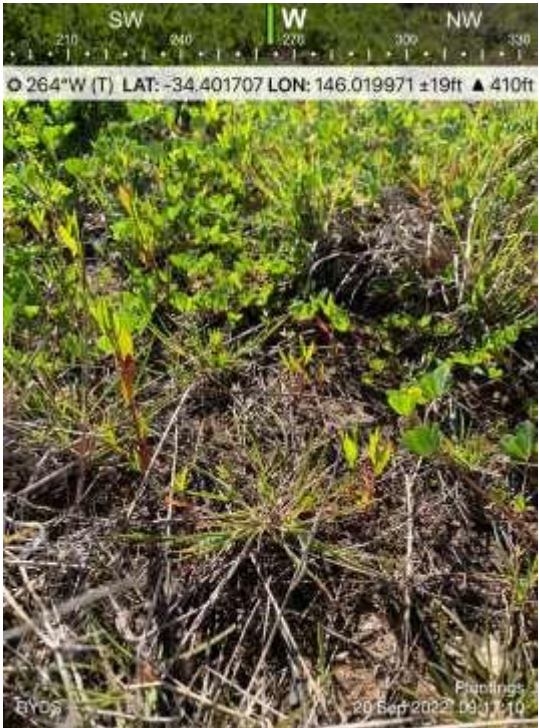
Photo 2: September 2022 establishment following direct seeding during April 2021

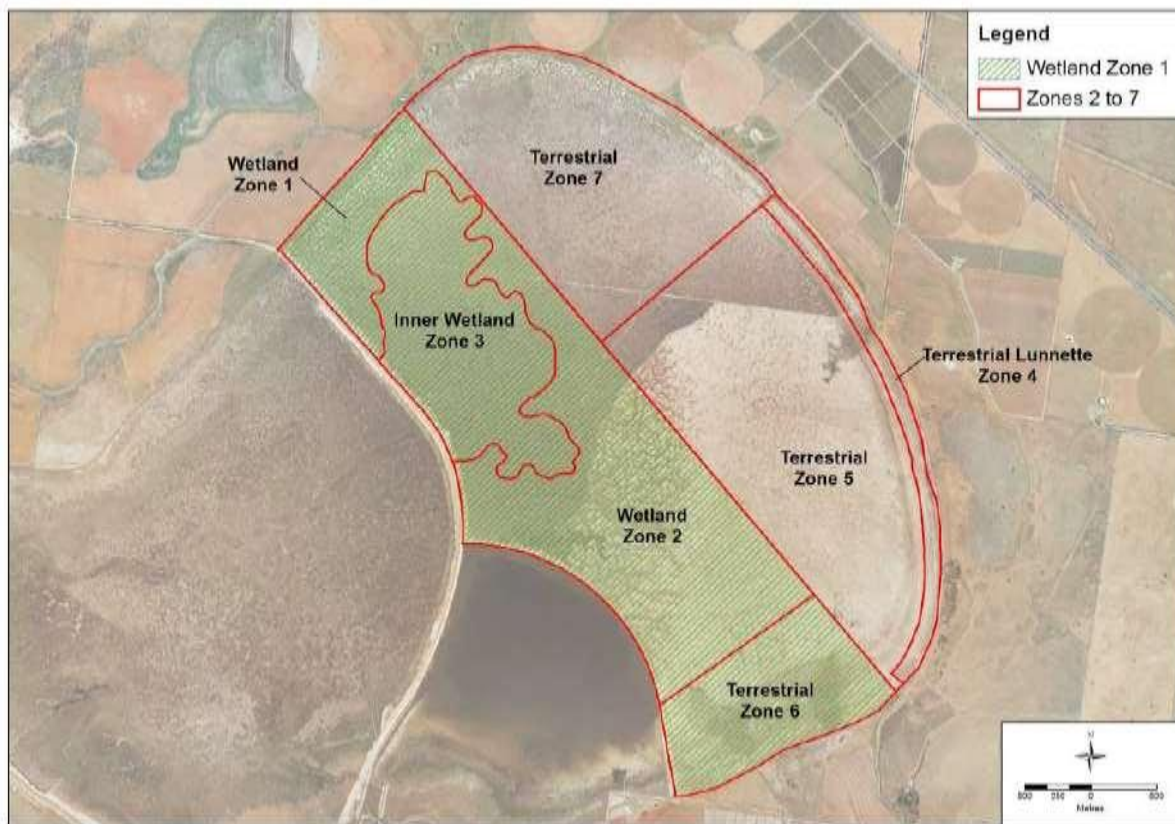
Figure 20: BBS Wetland cell planting zones for revegetation activities.

Figure 20 below reproduces Figure 25 of the plan showing the planting zones proposed for revegetation activities.

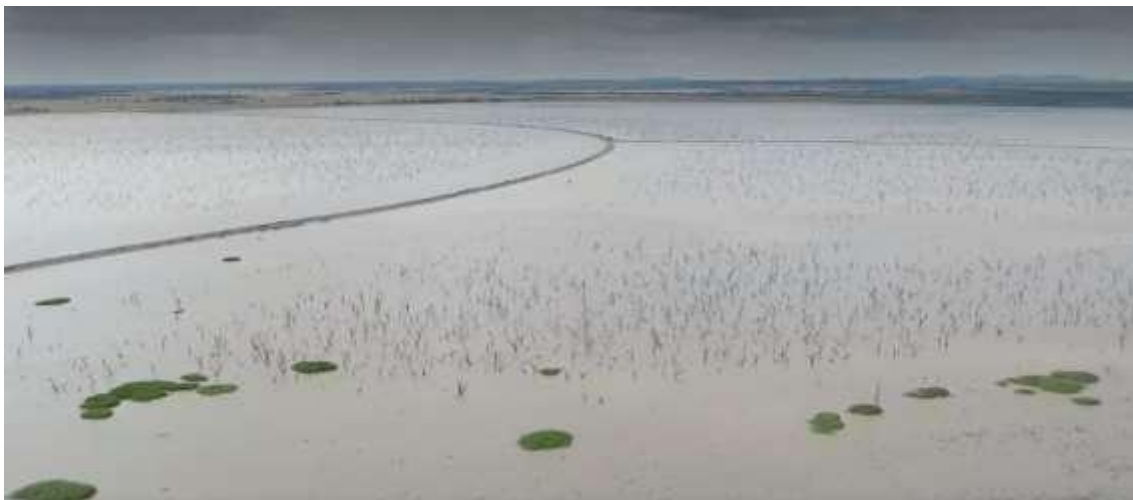
Figure 23: Drone photo taken 11 November 2022 of BBSW during the flood *Active cell top left, intermediate cell bottom left and wetland cell top right*

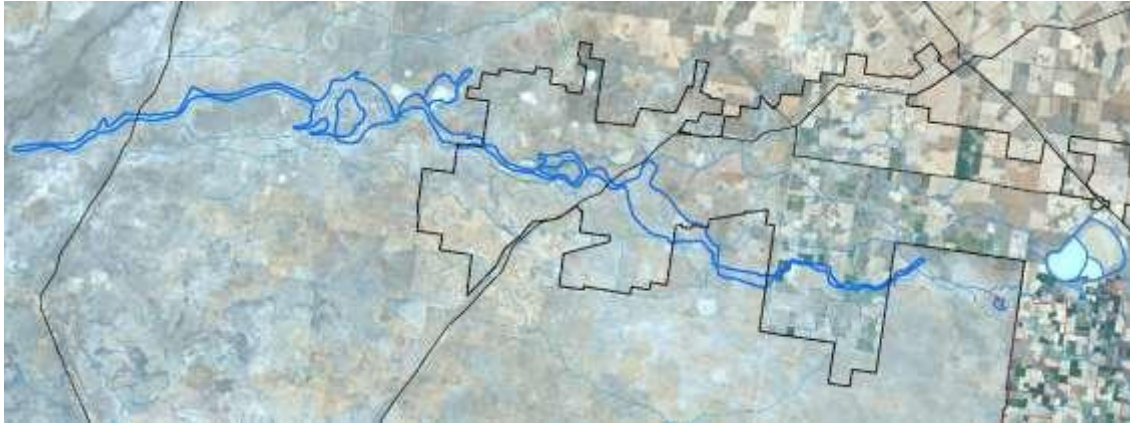
Figure 25: Lower Mirrool Creek Floodway location (MIA extent from 2019)

Aerial imagery from SixMaps utilised in MI Maps (MI's GIS mapping system)

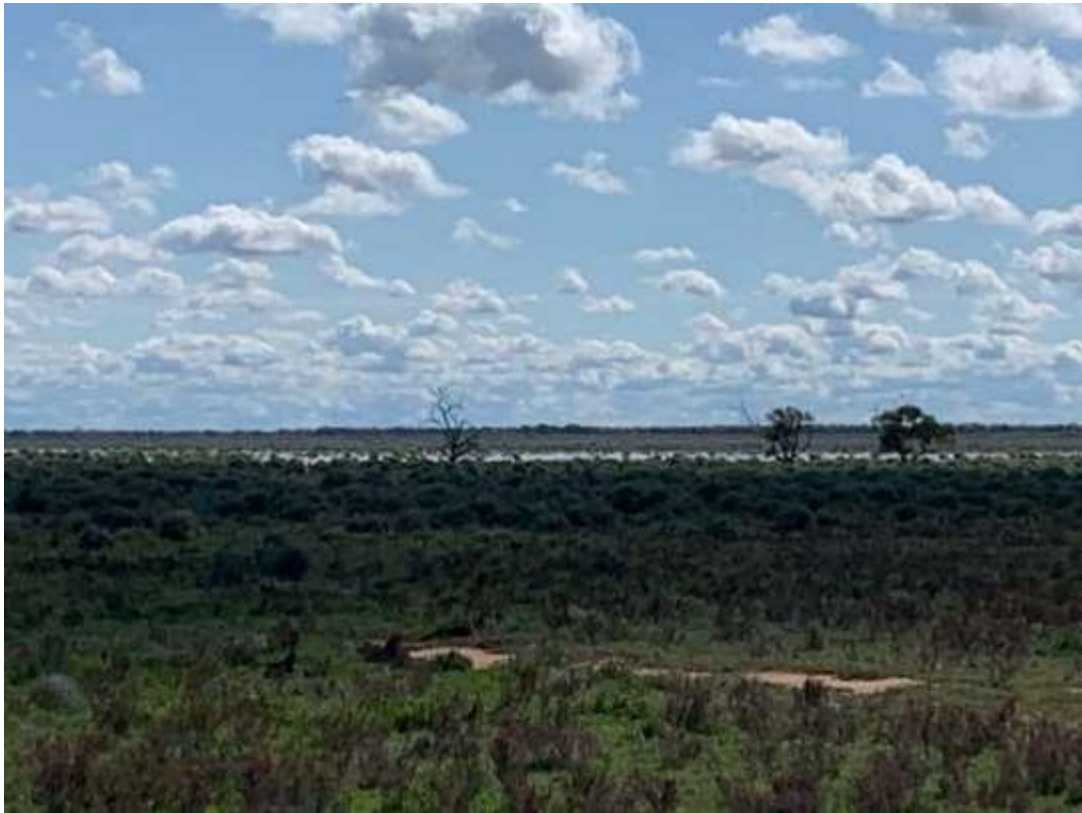
Figure 26: Griffith Flooding 26 August 2022 – area around Narrabri Swamp

The 2022 flooding occurred due to saturated catchments, prolonged rainfall with above average rainfall in the two years prior and many storages were at or near capacity. MI started to release

water via the Lower Mirrool Creek Floodway (MIRFLD) in August 2022. The water reached Narrabri swamp (**Error! Reference source not found.**) on 26 August 2022 and past the Mid Western Hwy during early September 2022 indicating that Five Oaks swamps were also being inundated.

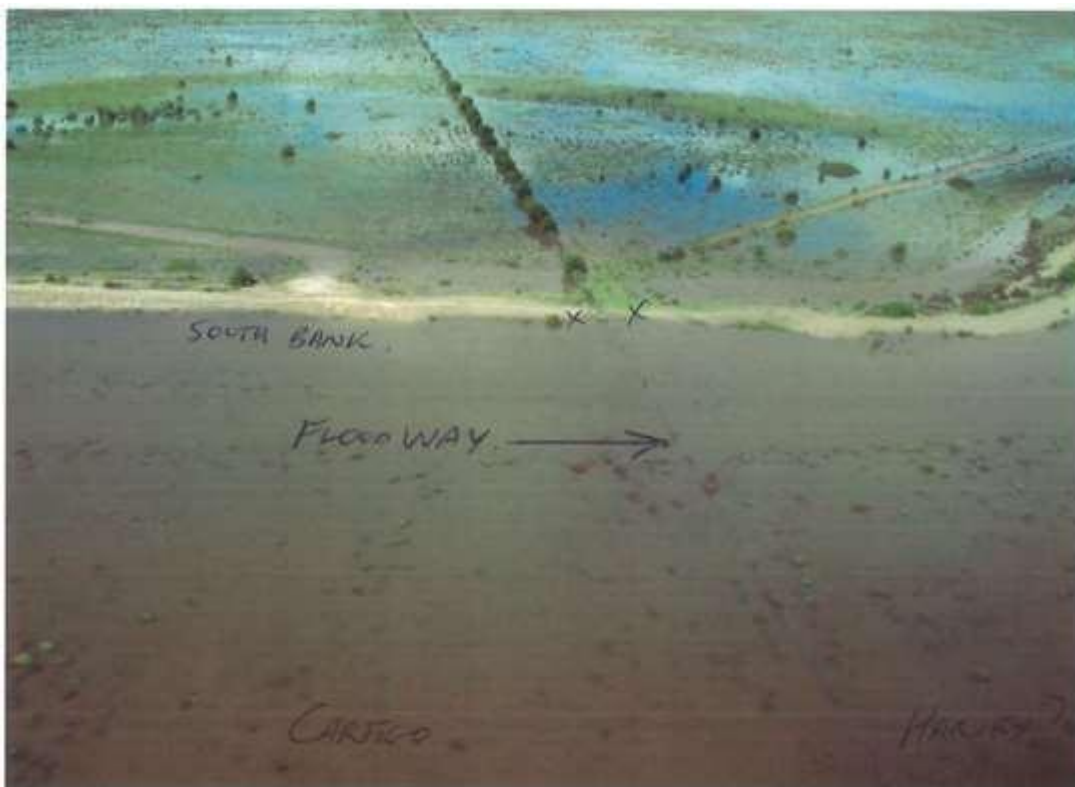
Figure 27: Griffith flooding 17 March 2012 – area around Narrabri Swamp

The 2022 flood event was very similar to 2012 and 2016 flood events as most of the wetlands located in the lower Mirrool Creek Floodplain experienced watering during the events (**Figure 27**). A total of 112,116 ML was released via MIRFLD during 2022 only 9,247 ML less than in 2016 and 4,775 ML less than 2012.

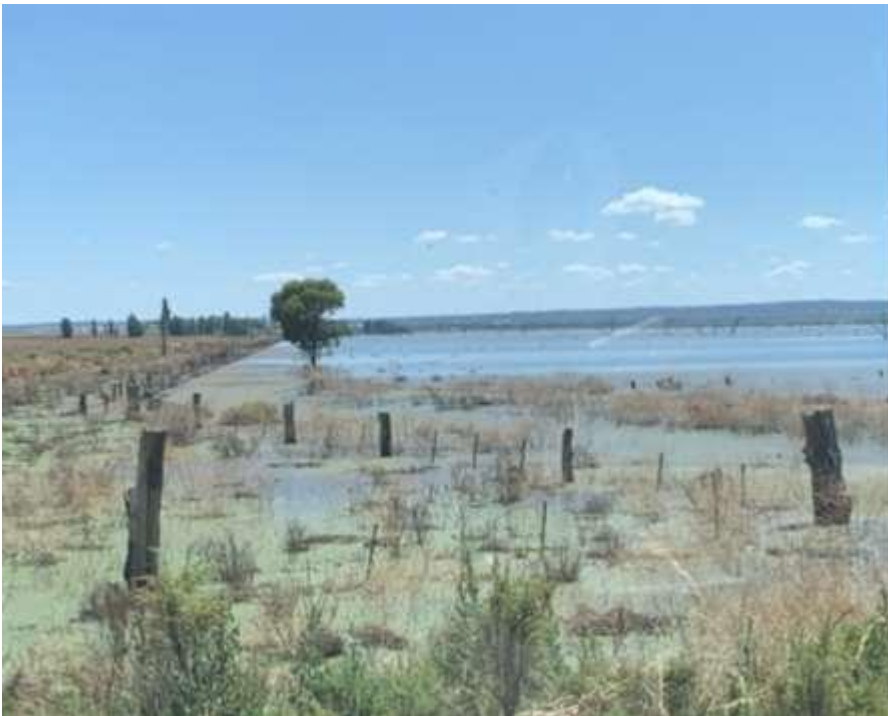
Figure 28: BBS Wetland cell inundation 11 January 2023

Due to the 2022 flooding that inundated the BBS wetland cell access has been restricted (**Figure 28**). However, MI were able to complete the due diligence investigations for ecological and cultural heritage risks for the BBS fencing project and the African Boxthorn biocontrol was released and trailed within the MIA at another location.
