Vegetation near irrigation pipelines and infrastructure

Clear access to irrigation infrastructure

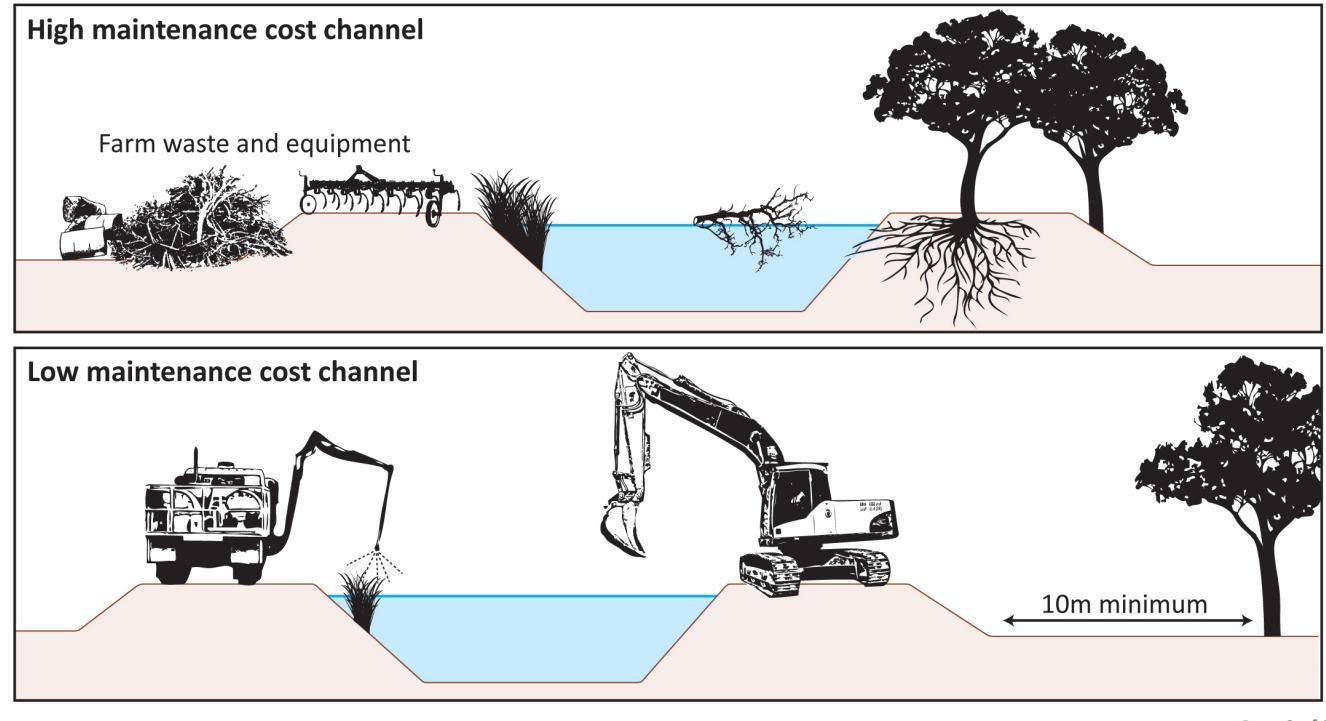
This diagram of a high maintenance cost channel illustrates the problems encountered by MI maintenance staff. Channels with trees at least 10 metres away and no obstacles allow us clear access for maintenance.

There are obvious safety aspects of having vegetation close to irrigation channels. If vegetation is within 10 metres of a channel, other problems may include:

- Tree roots can become invasive
- Tree branches may fall into the water and block structures downstream
- MI may need to remove obstacles to allow access for maintenance. You could be liable for the costs incurred so please work with us to ensure clear access.
